THE ARCHAEOLOGY OF SHORE STRANDED SHIPWRECKS OF SOUTHERN
BRAZIL

A Dissertation

RODRIGO DE OLIVEIRA TORRES

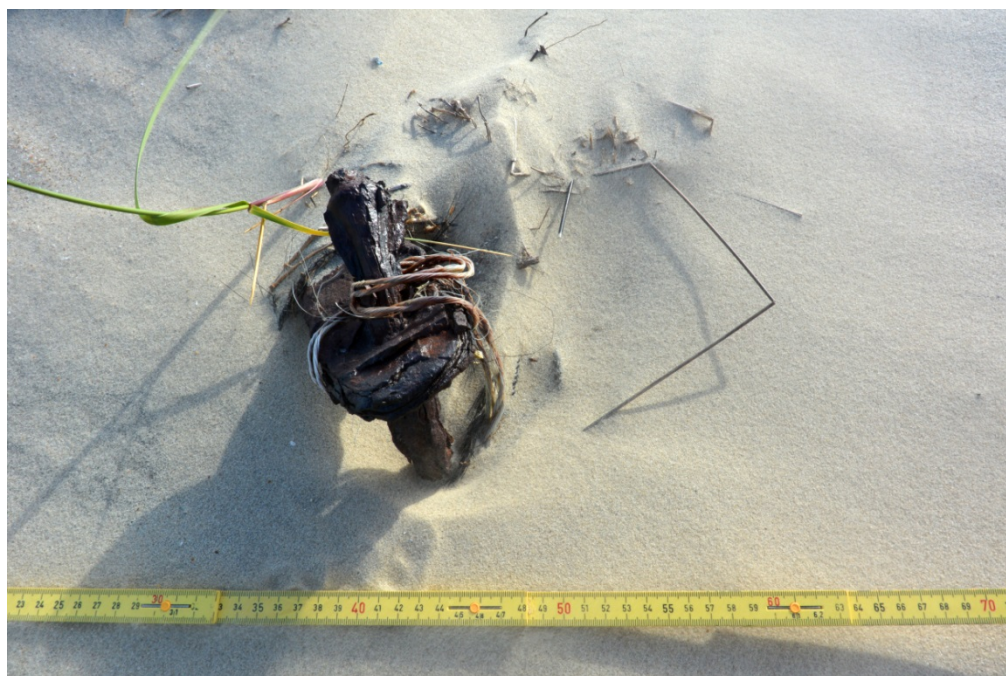
Figure 76. Other naturally exposed iron fasteners observed at the NAV Inédito B site in 2013.

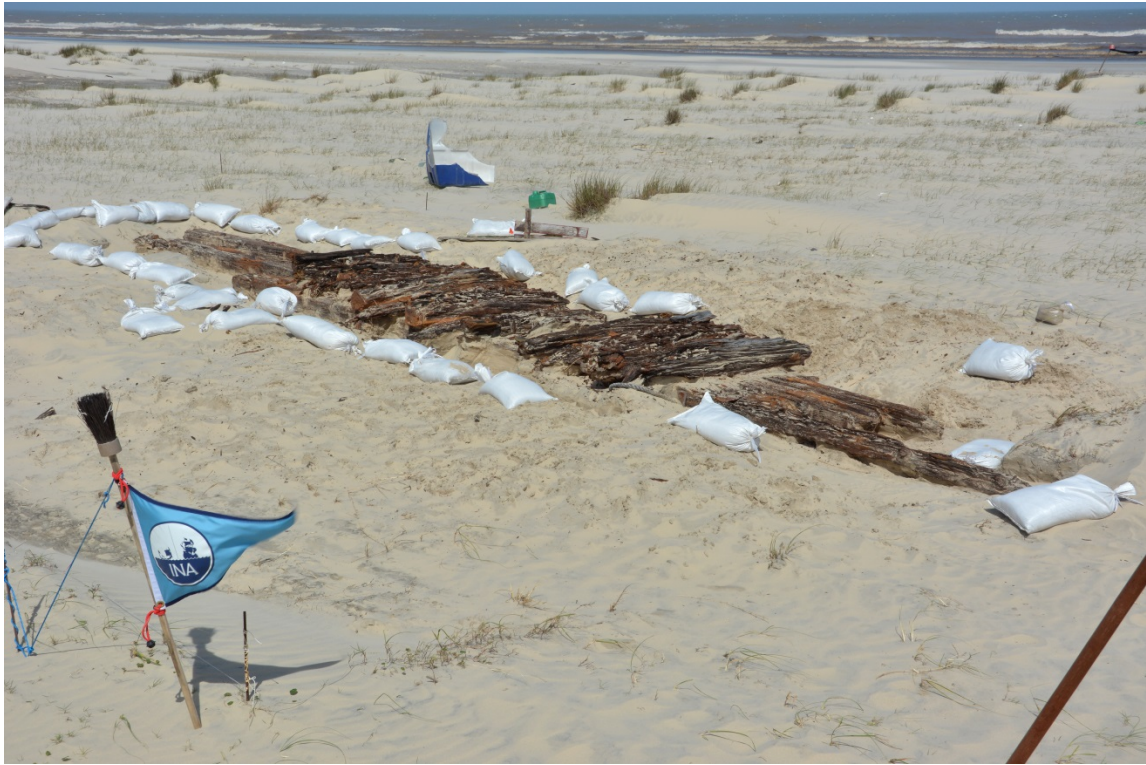
Figure 78. Main structure at NAV Inédito site, as excavated in 2013.

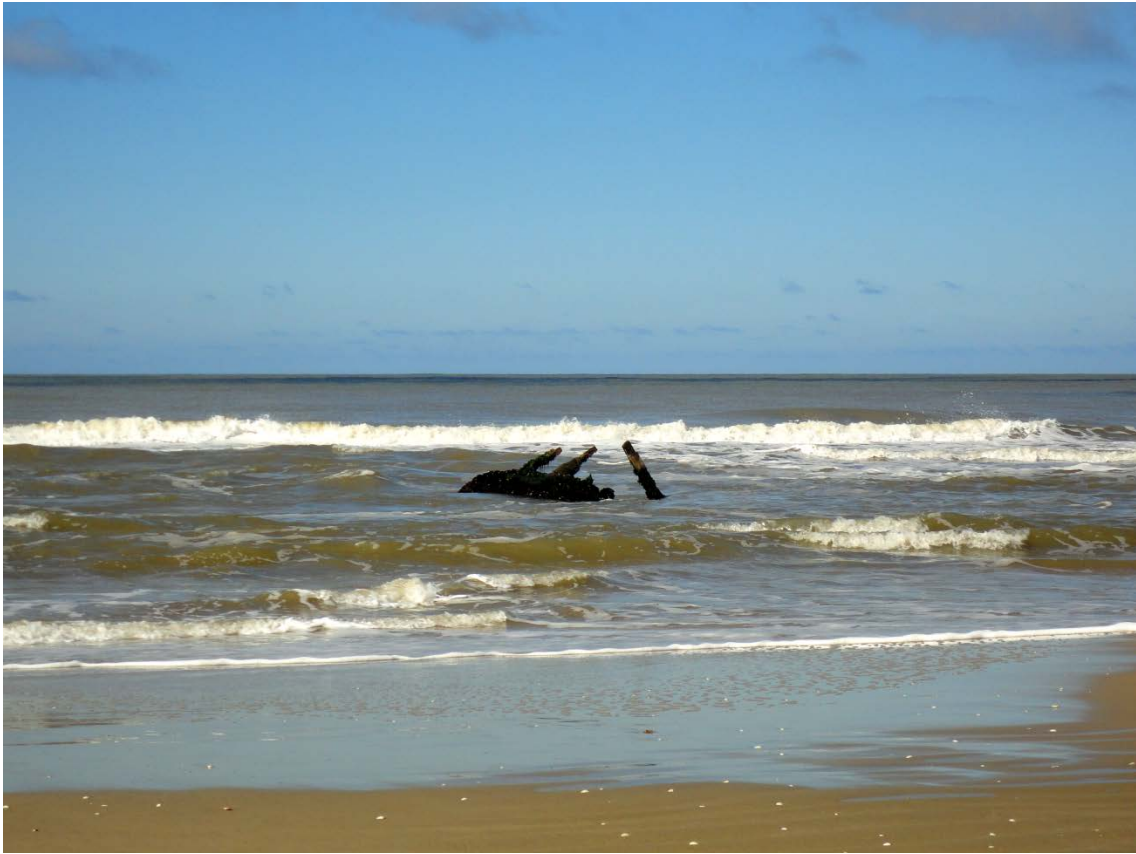
Figure 82. NAV Ponteira as seen much degraded in 2011.

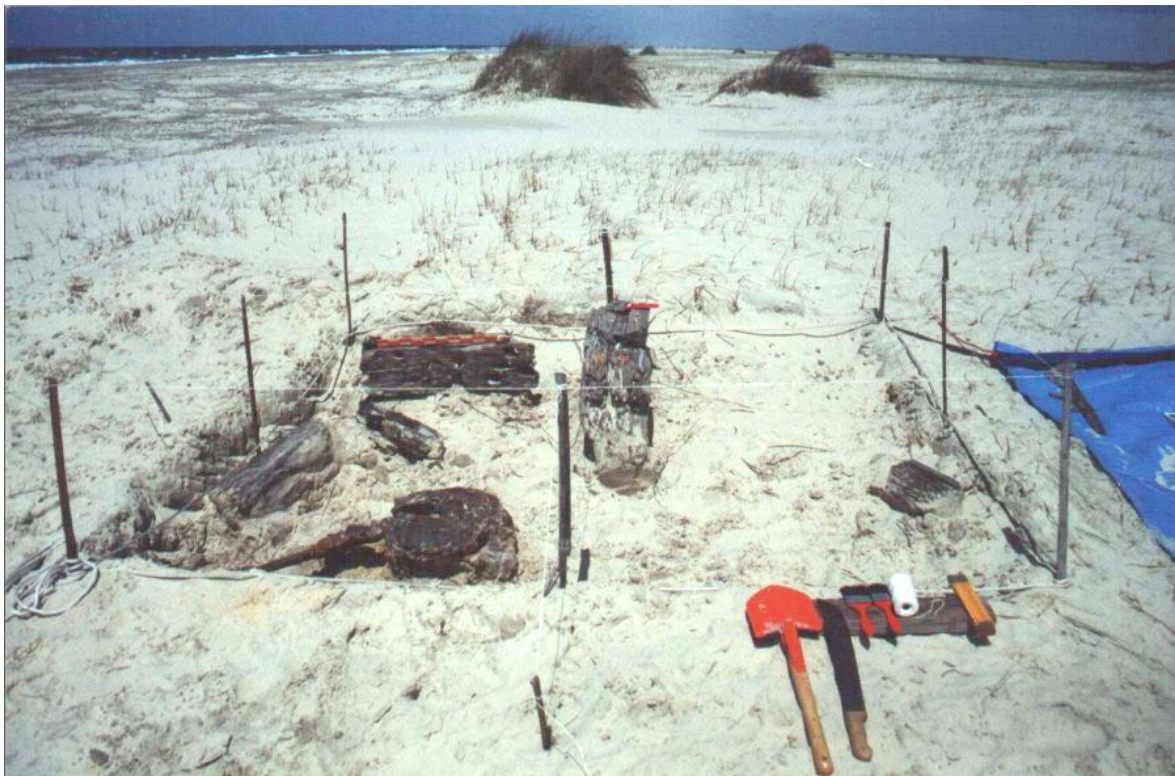
Figure 102. Test pit at NAV Navio dos Couros site excavated in 2003, showing exposed timber fragments.
